Spatial Transformation in the Context of Refunctioning and Sustainability; Nicosia Eagle Eye Boutique Hotel

M. Selen ABBASOĞLU ERMİYAGİL*
Cemaliye SUNALP GÜRÇİNAR**

Article Type: Research | Received Date: 25.05.2022 | Acceptance Date: 20.06.2022

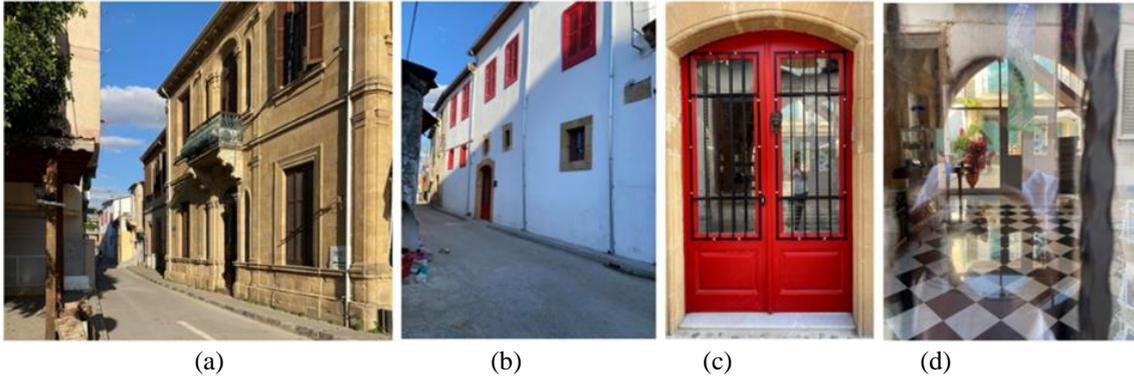
The location of the street and entrance to the building after completion of renovation in 2019 is shown in Figure 2. With the aim of reviving the architecture and historical texture in Nicosia, the building was refunctioned and opened as a boutique hotel.

Fig. 2. (a) and (b) street facade of the building (c) and (d) main entrance of the building

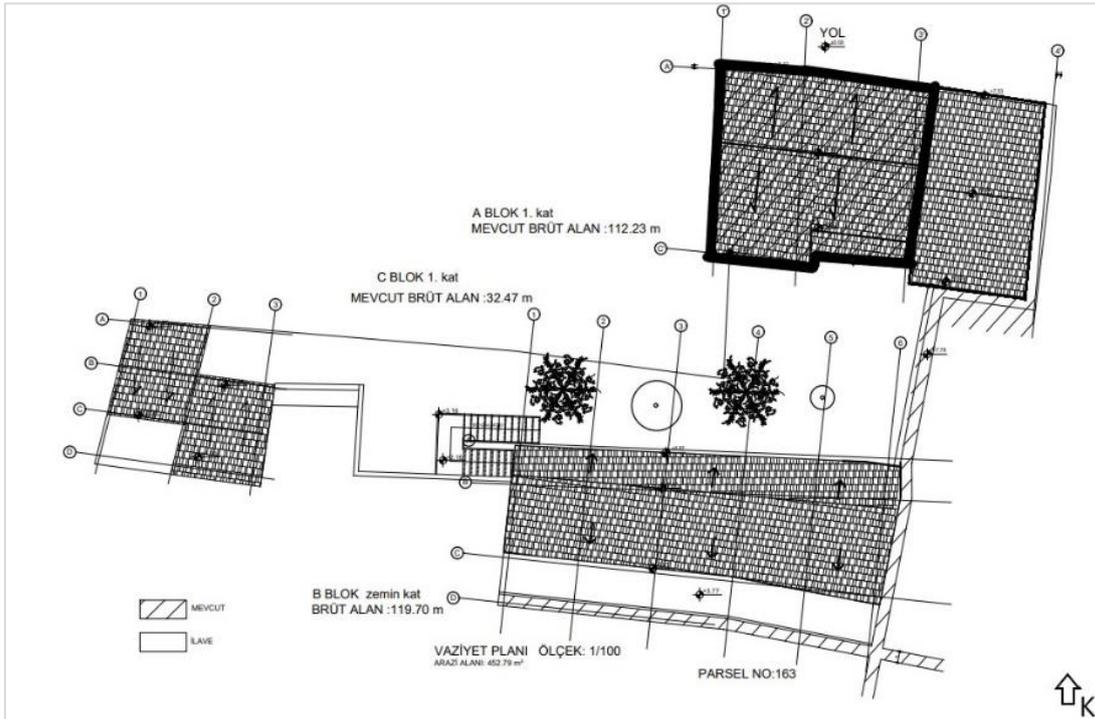
The present building, registered as group II building according to the Turkish Republic of Northern Cyprus “Supreme Council of Immovable Antiquities and Monuments” comprises a ground floor (entry floor) and 1st floor. As seen in the site plan of the building in Figure 3, the building located in the front is original and the rear parts are sections added in accordance with the original. Within the scope of the study, the focus was on the original part of the building. The ground floor of the building was preserved as it was originally. On the first floor, the room located in the east end was added linked to the character of the original building, while the remaining parts were preserved.

Fig. 3. Site Plan of the Nicosia Eagle Eye Boutique Hotel [6]

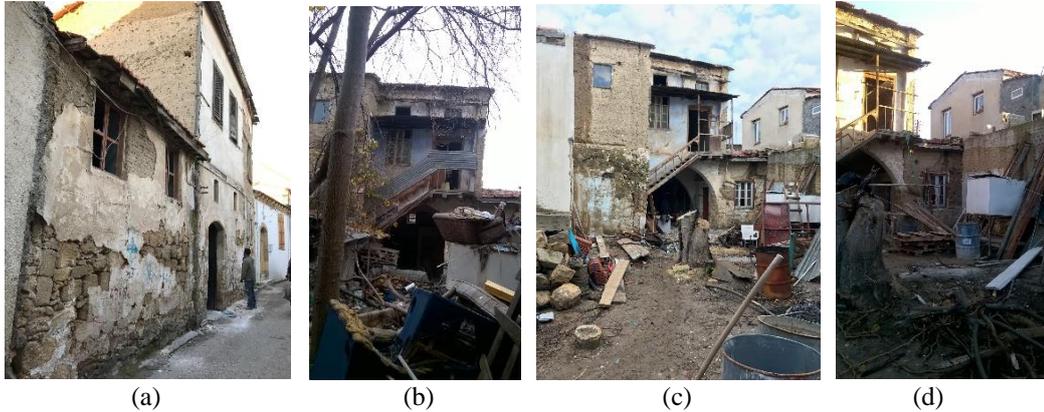
The main entry door to the building opens directly onto Celaliye Street. The two-wing wooden entry door with wrought iron details was placed in the building by considering the original period. This door opens into the ground floor entry hall. The original pictures of the building can be seen in Figure 4.

Fig. 4. (a) street facade of the building, (b), (c) and (d) courtyard of the building in 2016 (Güvenir Beyatlı, 2021)

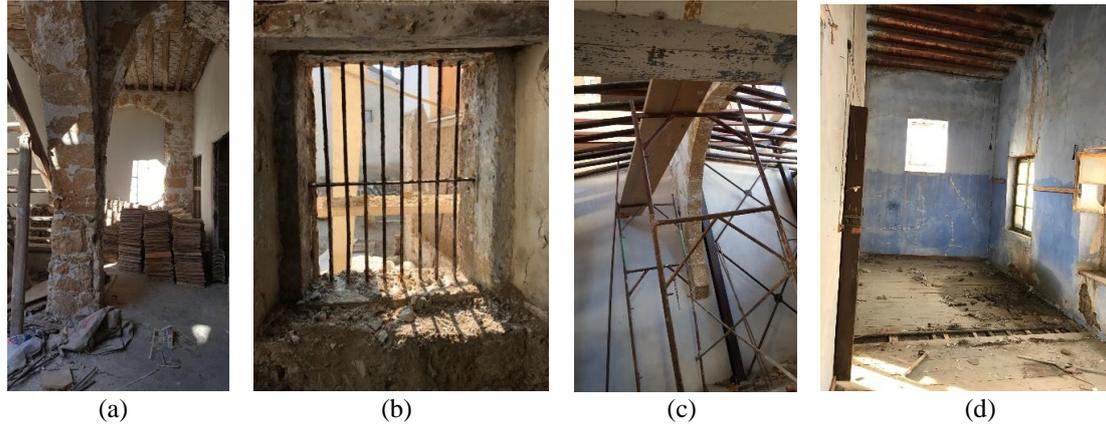
The load-bearing system for the original portion of the Eagle Eye Boutique Hotel comprises yellow stone, adobe and a wooden carcass. The original ceilings in the building remained in place to the present day in places. The original rafters in the ceiling used rusty wooden overlays. The floor of the building was laid with ceramic tiles reflecting the original period. The first floor is reached from the outside by a wooden staircase with classic wooden bannisters through an arched corridor. The roof of the building is a hipped roof, covered with Marseille-type clay tiles. Iron grilles were used on the windows. The floor of the building is massive wood. Passage within the building and to the balconies is through arches with wide openings (Fig. 5).

Fig. 5. (a) balconies of the building, (b), (c) and (d) interior of the building in 2016 (Güvenir Beyatlı, 2021)

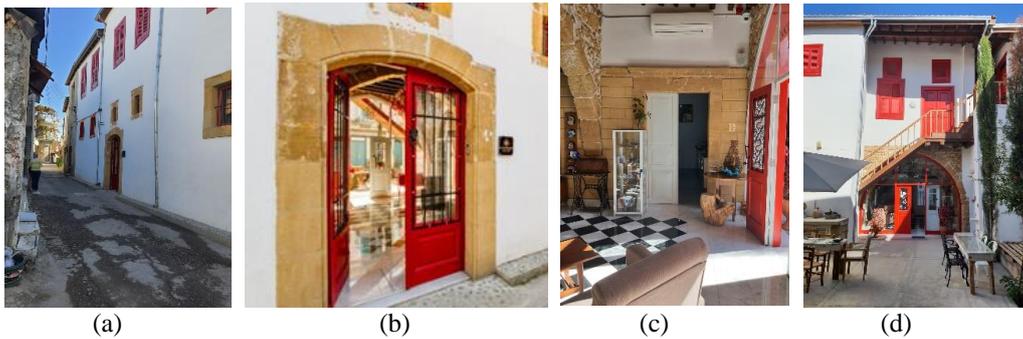
The building was purchased by Master Architect Birgül Güvenir Beyatlı in 2016 and project work began. Revival of the Degree II listed building by refunctioning as a boutique hotel in accordance with the original building was approved by the Turkish Republic of Northern Cyprus Supreme Council of Immovable Antiquities and Monuments. According to decision, Degree II buildings must be preserved in accordance with their original form with priority given to the textural value. It is necessary to renovate in a way that does not disrupt the texture of the façade, especially. In this context, it is necessary to preserve the original building, add any additions so they are compatible with the original, and maintenance and repair must be completed according to these criteria. All additions were renovated with permission from the preserved buildings council. During the renovation of the building, the originality of the building was researched by historians and original wall decorations and all historical details were investigated and preserved. The building was refunctioned as a boutique hotel in 2019.

Fig. 6. (a) street facade of the building (b) and (c) main entrance of the building, (d) courtyard of the building after renovation

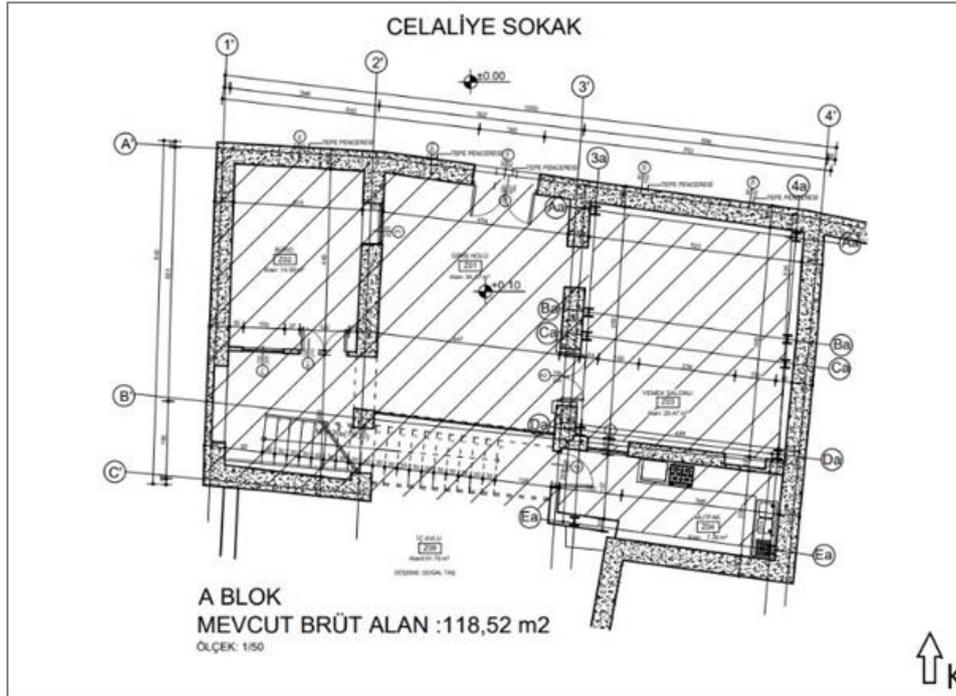
The ground floor plan comprises a total of four rooms organized as an entry hall, section used as an office, dining room and kitchen.

The ceilings of all rooms on the ground floor had their character preserved. The original wooden ceilings were strengthened and repaired using original rafters. Openings present in the walls were preserved in their original form. There are rooms located to the east and west of the main entry. The rear section of the room located to the east of the main entry on the ground

floor currently contains an area used as a kitchen (Fig. 7). The rear section of the room located to the west of the main entry passes into the stairway hall. The main entry opens to a space considered to be a transit area with a two-wing door. This space allows passage to the dining room, kitchen and courtyard (Fig.8).

Fig 7. Ground Floor Plan (Güvenir Beyatlı, 2021)

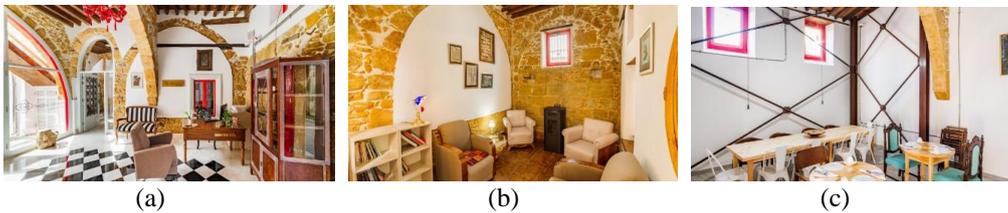
Fig. 8. (a) main entrance of the building, (b) director office room (c) (d) dining room of the building after renovation

This building, refunctioned as a boutique hotel, preserved the load-bearing and division walls in original form and created spaces accordingly. In some sections strengthening of the existing building was performed. Steel columns were added to structurally strengthen the ceilings of the ground floor (Figure 8-Picture 4). Generally, the original load-bearing elements and structure of the building were preserved and additionally strengthened with different load-bearing systems.

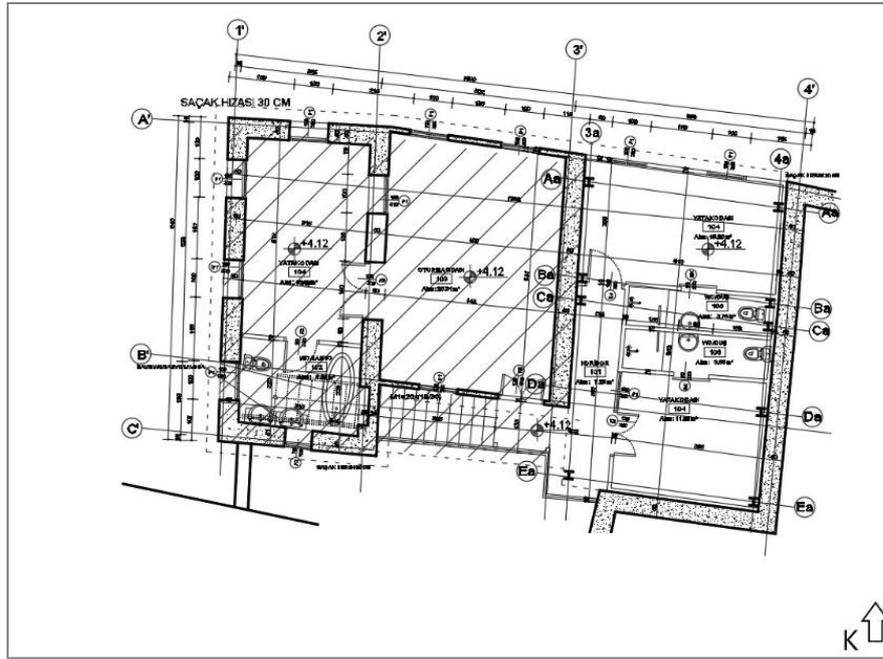
The first floor is reached through the rear section of the room located to the west of the main entry on the ground floor. As can be seen from the first floor plan, there are two rooms located in the west. In the east section a room was added in accordance with the original. The room renovated as a suite room in the east section is entered through a sitting room with a bedroom in the internal west section. The original wooden ceilings were preserved and a semi-open shower and WC were added within the room so as not to damage the existing walls. Figure 10 (b) shows the added wet space.

The section added in the east end was designed as two small hotel rooms with a connecting corridor. Ventilation and lighting for the added rooms is provided from north and south aspects. No opening was made in the east wall, which is an adjoining wall. Traces of a bay window located in the existing structure can be seen on the north façade of the building. As this would prevent vehicle traffic due to proximity to the street, it was not added to the building in line with the decision of the Supreme Council of Immovable Antiquities and Monuments.

Fig. 9. First Floor Plan (Güvenir Beyatlı, 2021)

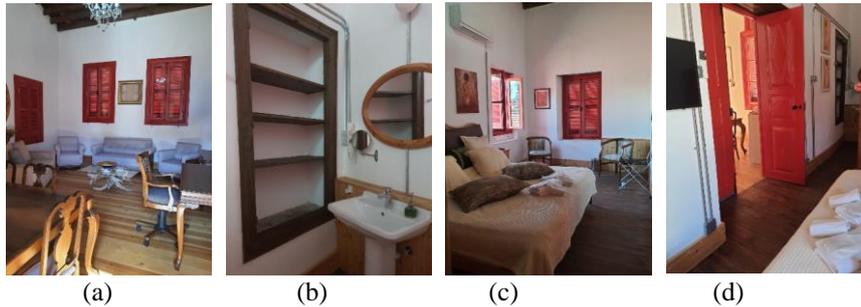
Fig. 10. (a) living space of the suite room, (b) living space of the suite room (c) and (d) bedroom of the suite room after renovation
